PBY Catalina

Walk Around

By William Scarborough

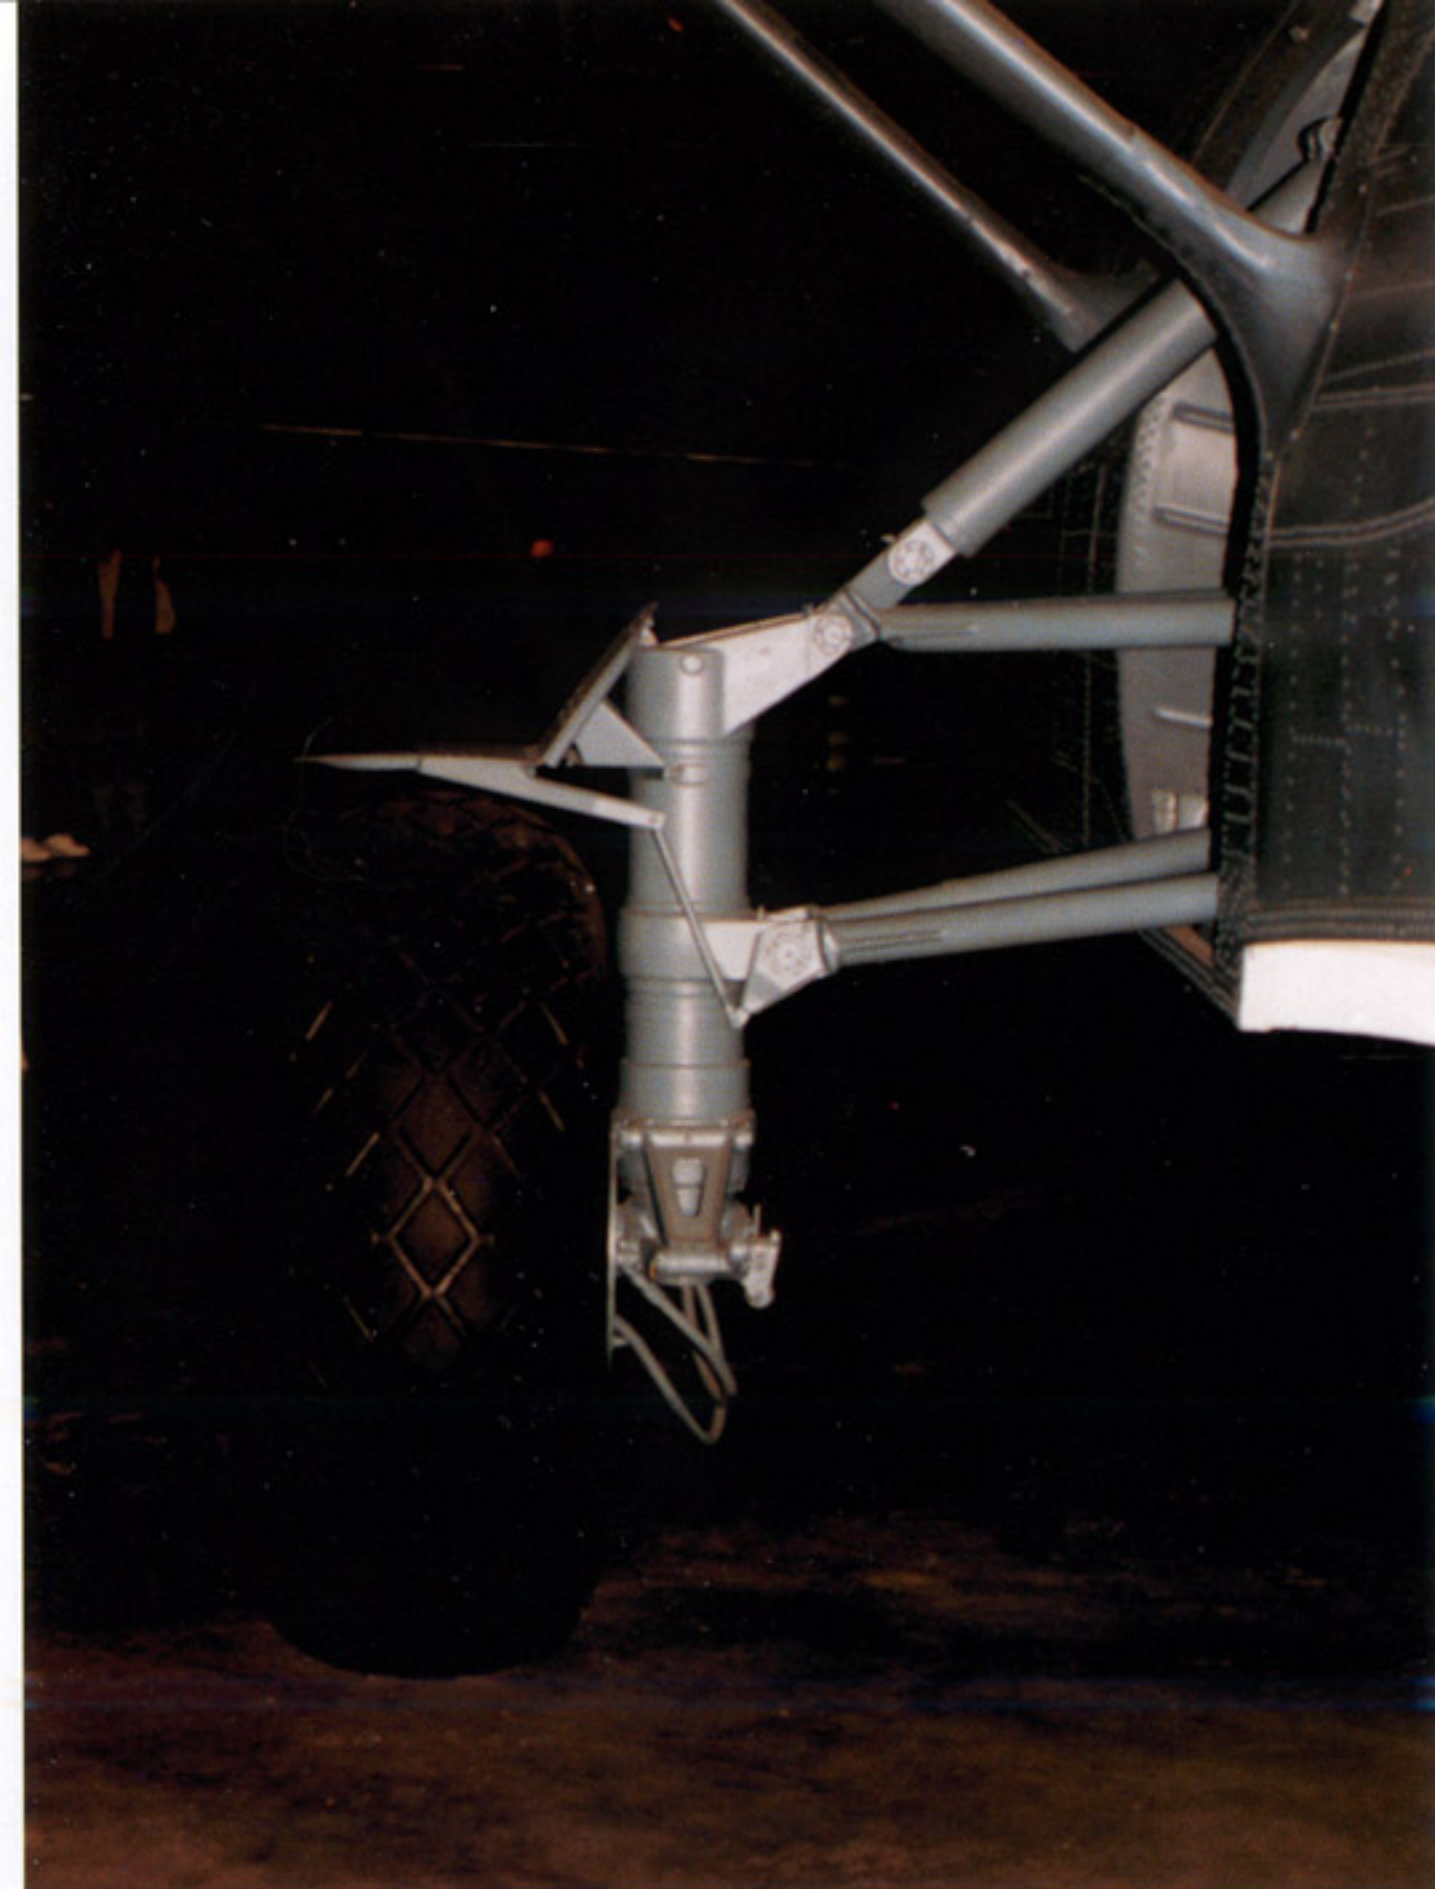
The small door above the wheel covered the upper opening of the wheel well for improved aerodynamics and to reduce drag. The main wheel itself served to seal the lower portion of the wheel well. The installation of landing gear on the PBY cut down on internal volume, making the PBY-5A less comfortable on long patrols than the flying boat PBY-5. (B. Ryle)

The port main landing gear, tire and wheel well of the Air Force Museum's OA-10A. The main wheel folded upward to rest in the wheel well between the wing struts. (B. Ryle)

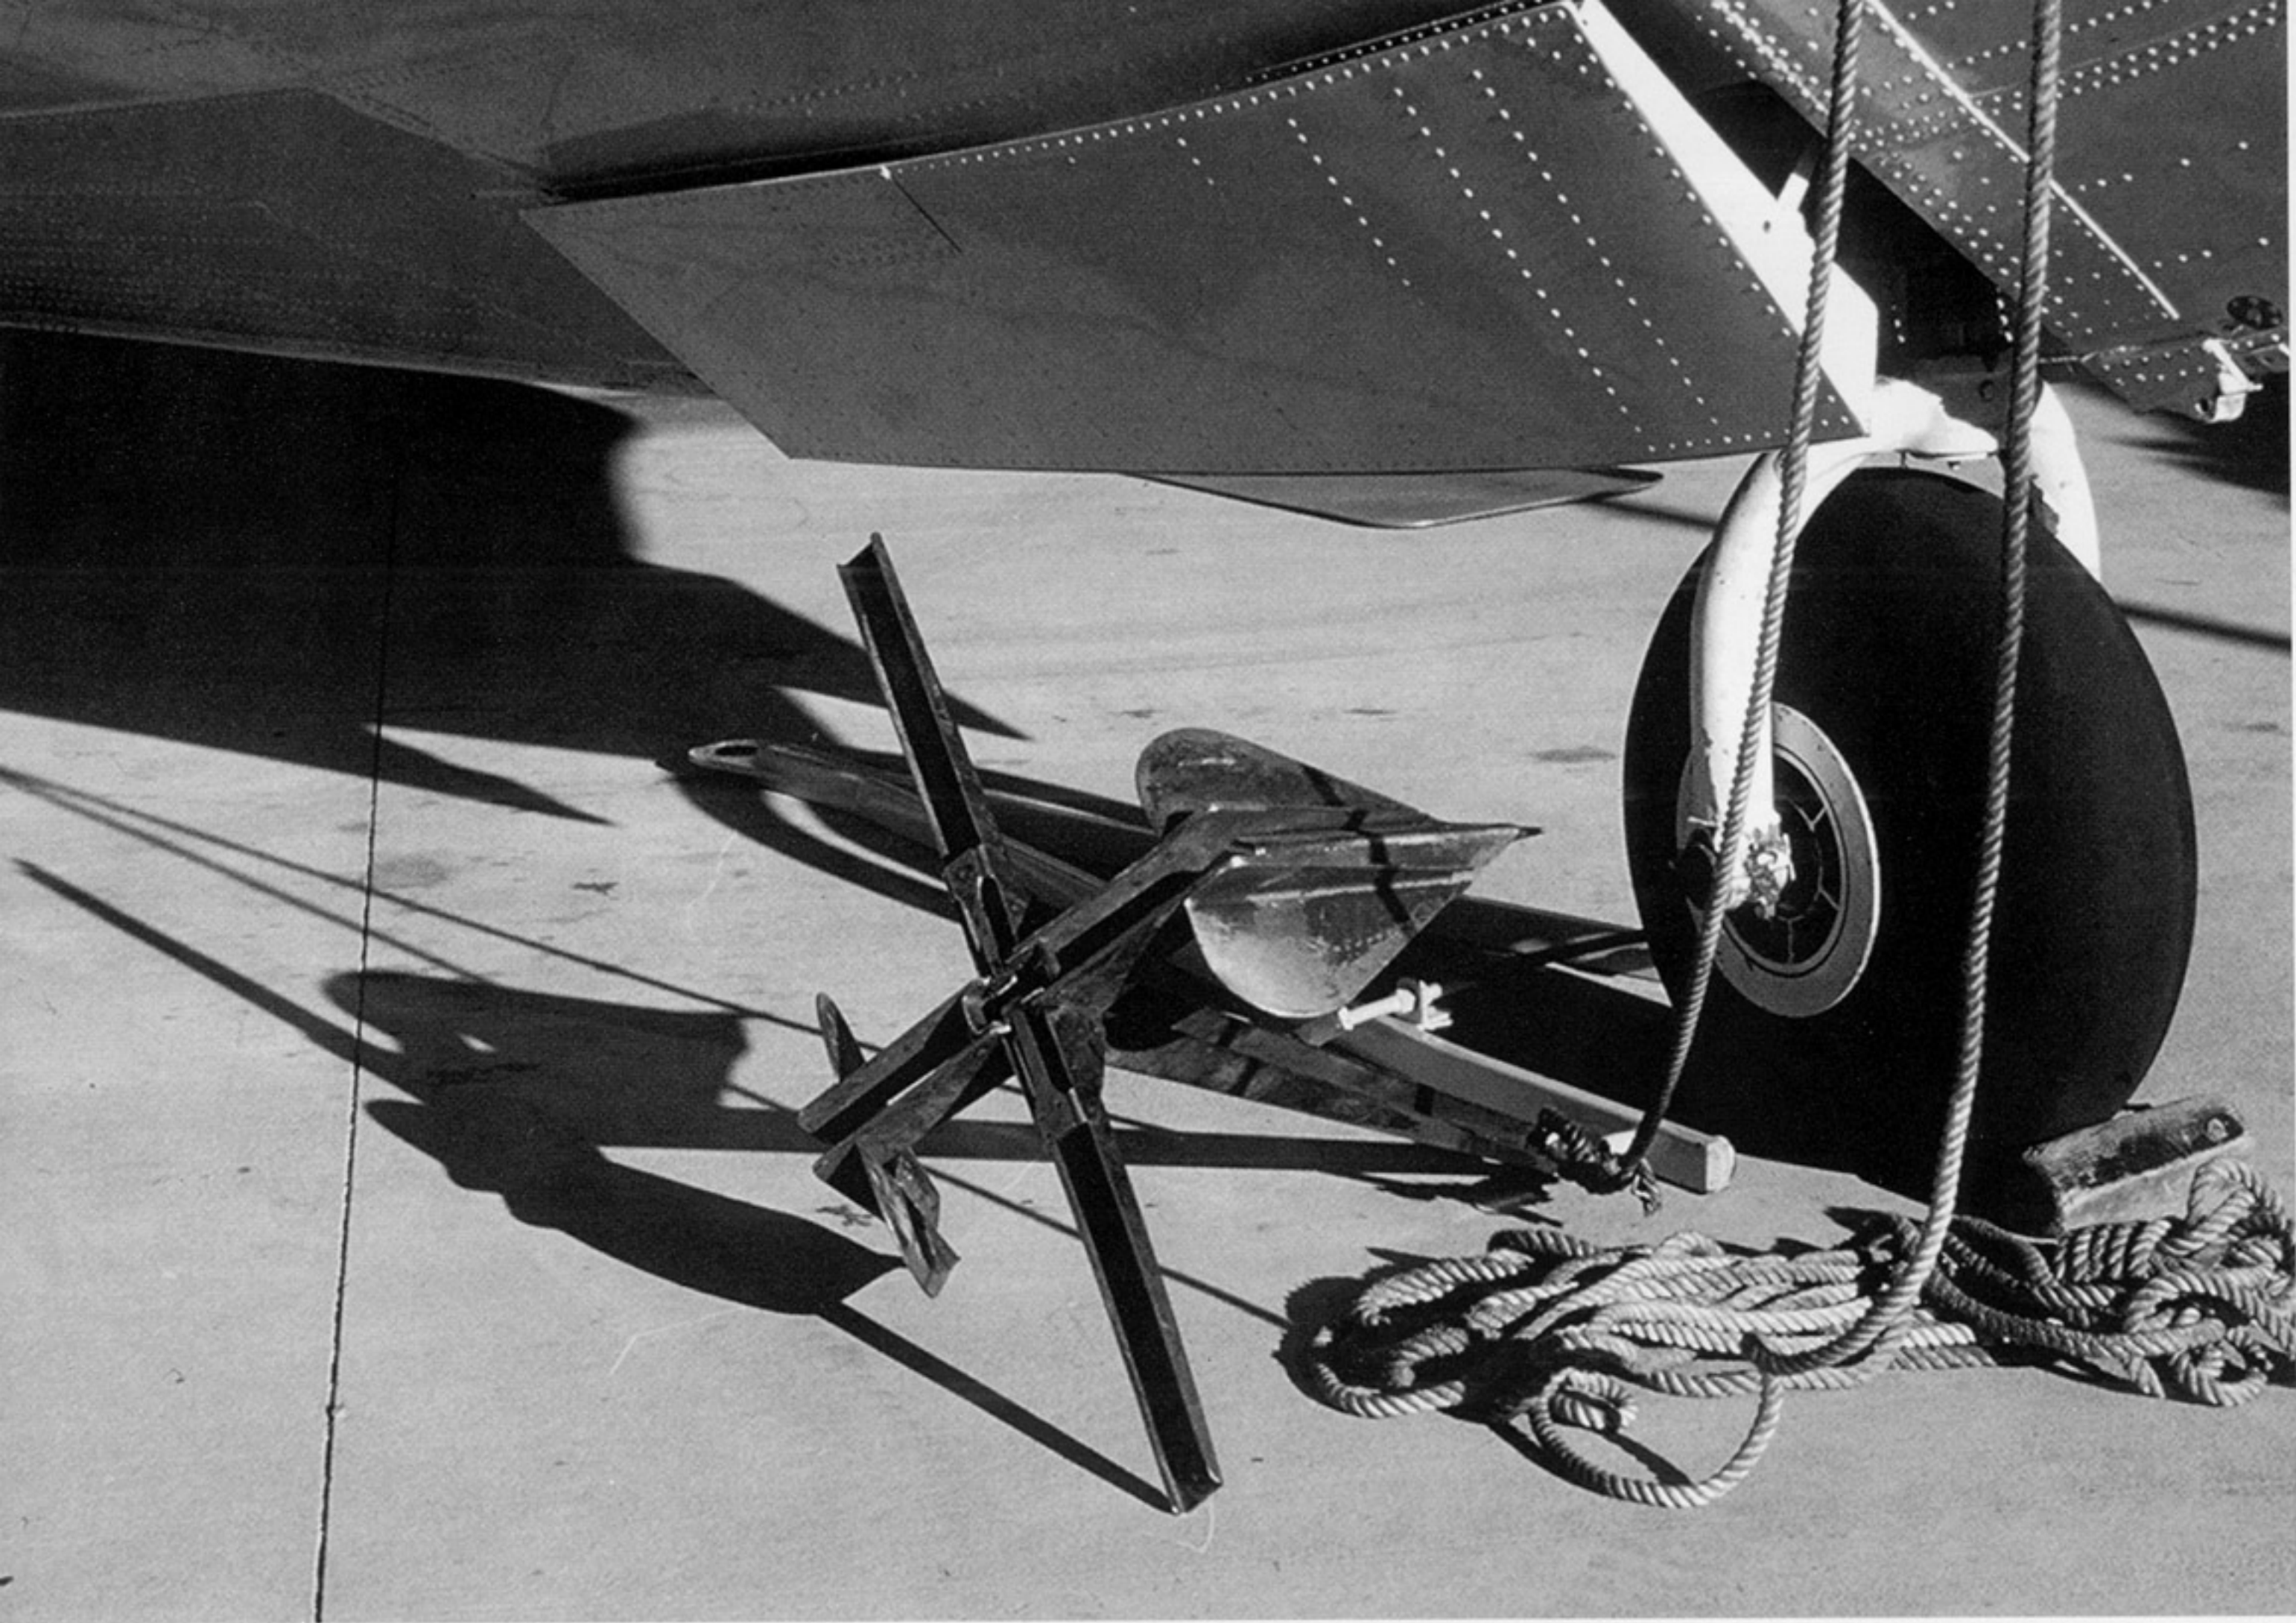
This is the nose wheel, nose wheel doors, anchor and anchor line of the Confederate Air Force PBX-6A. The anchor is usually stored in a compartment on the port side of the nose. The fully steerable nose wheel with a smooth tire and twin fork mount. Service Cats used this type of anchor with a stainless steel wire anchor cable. (Mark Aldrich)

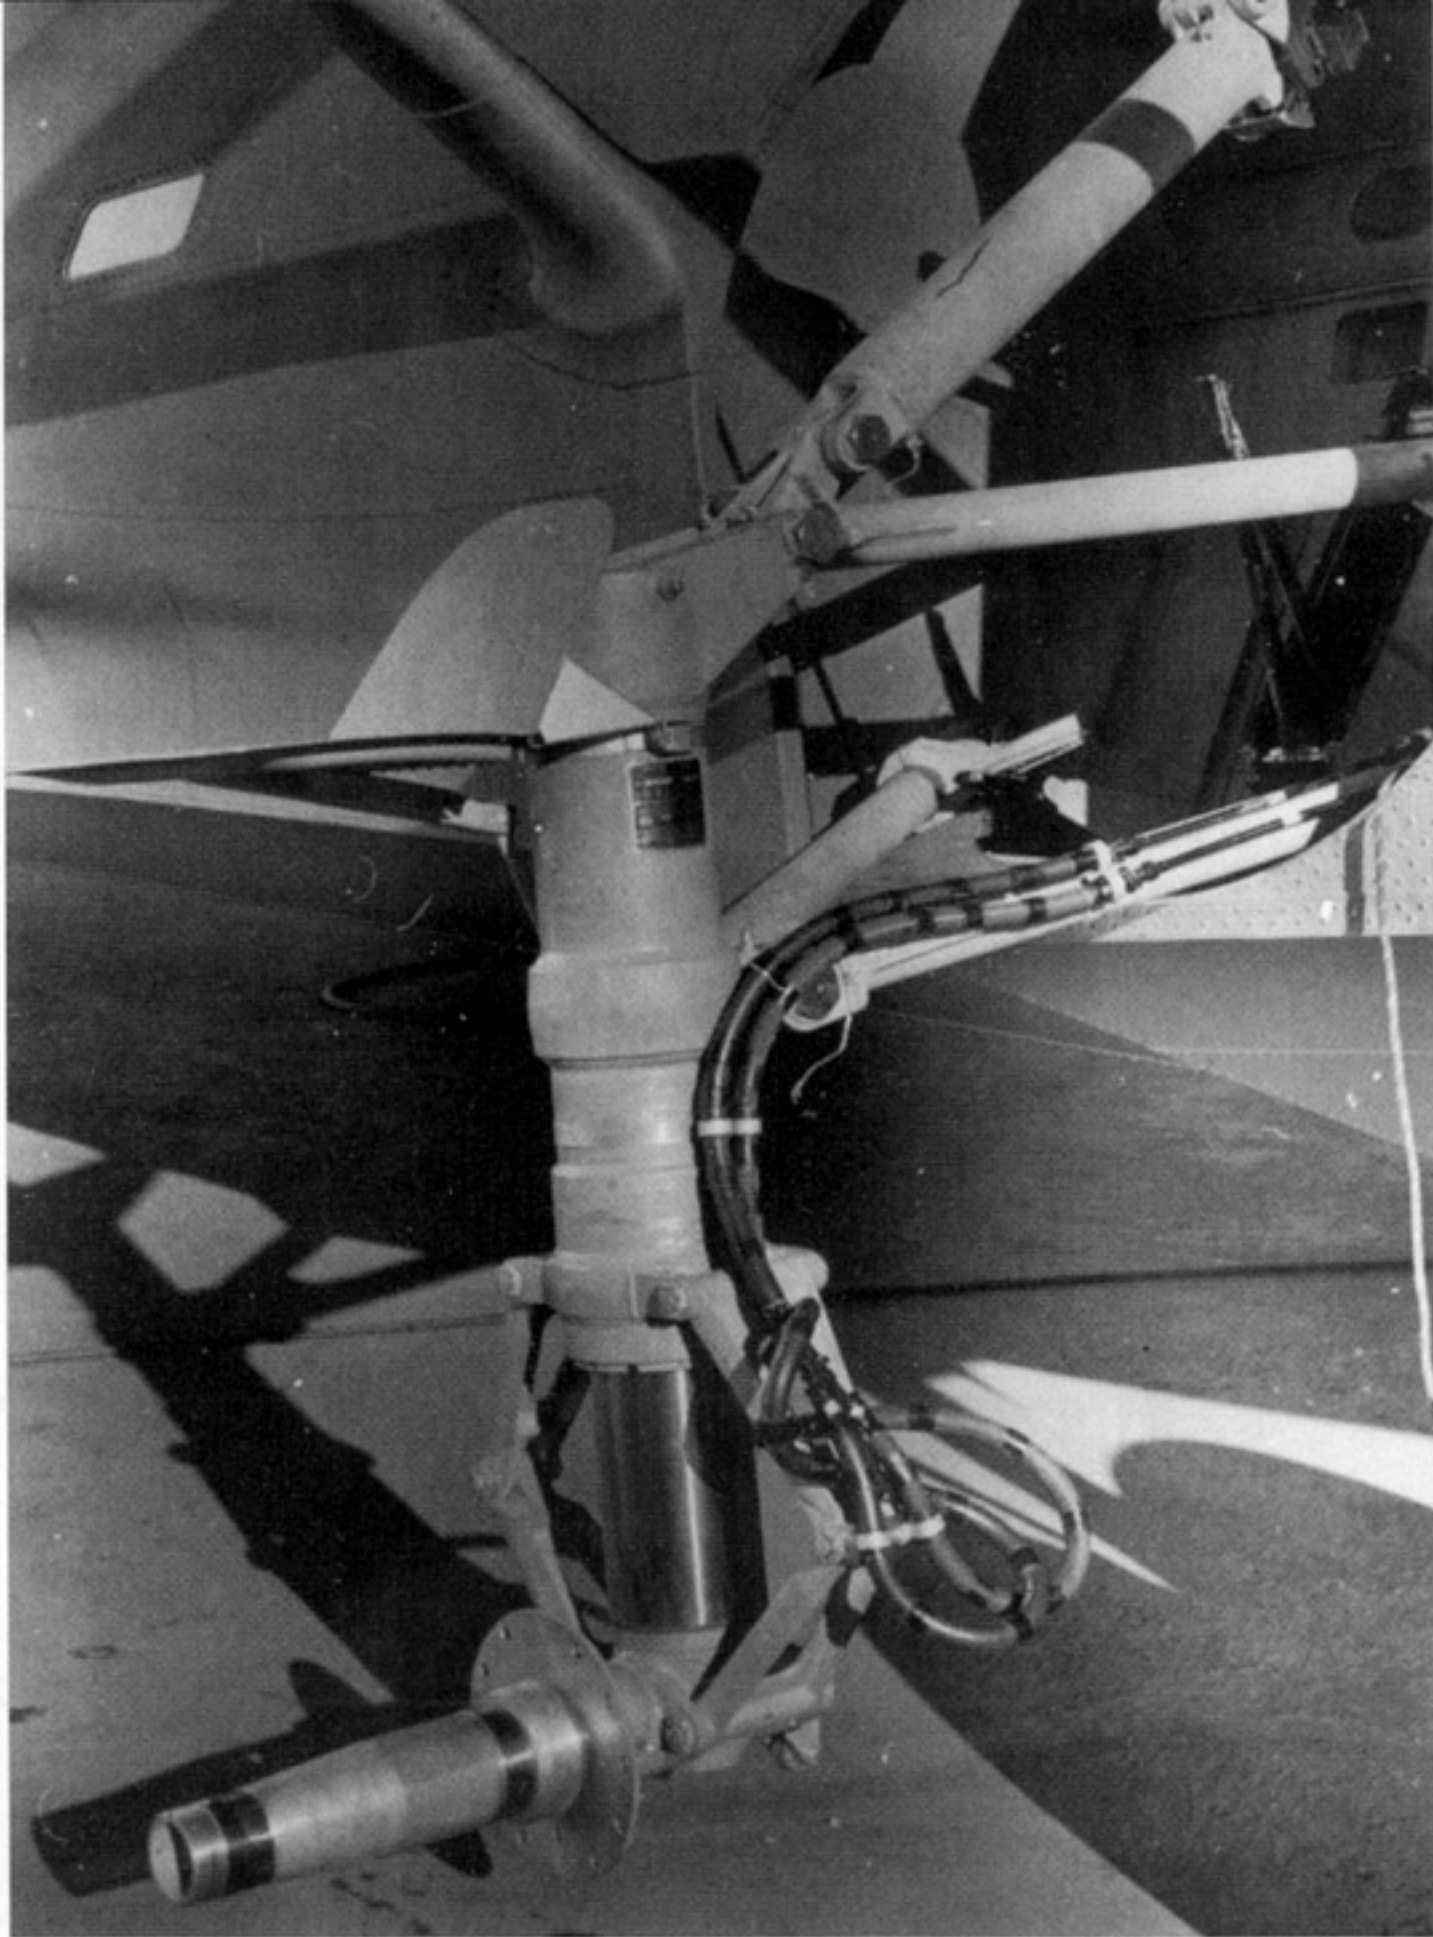
This is the starboard main landing gear of a PBY-5A/OA-10A, with the wheel and tire removed. The bright area is the oleo strut, behind it is the oleo fore and aft scissors, while below it is the axle. The Black tubes are hydraulic lines. (CAC)

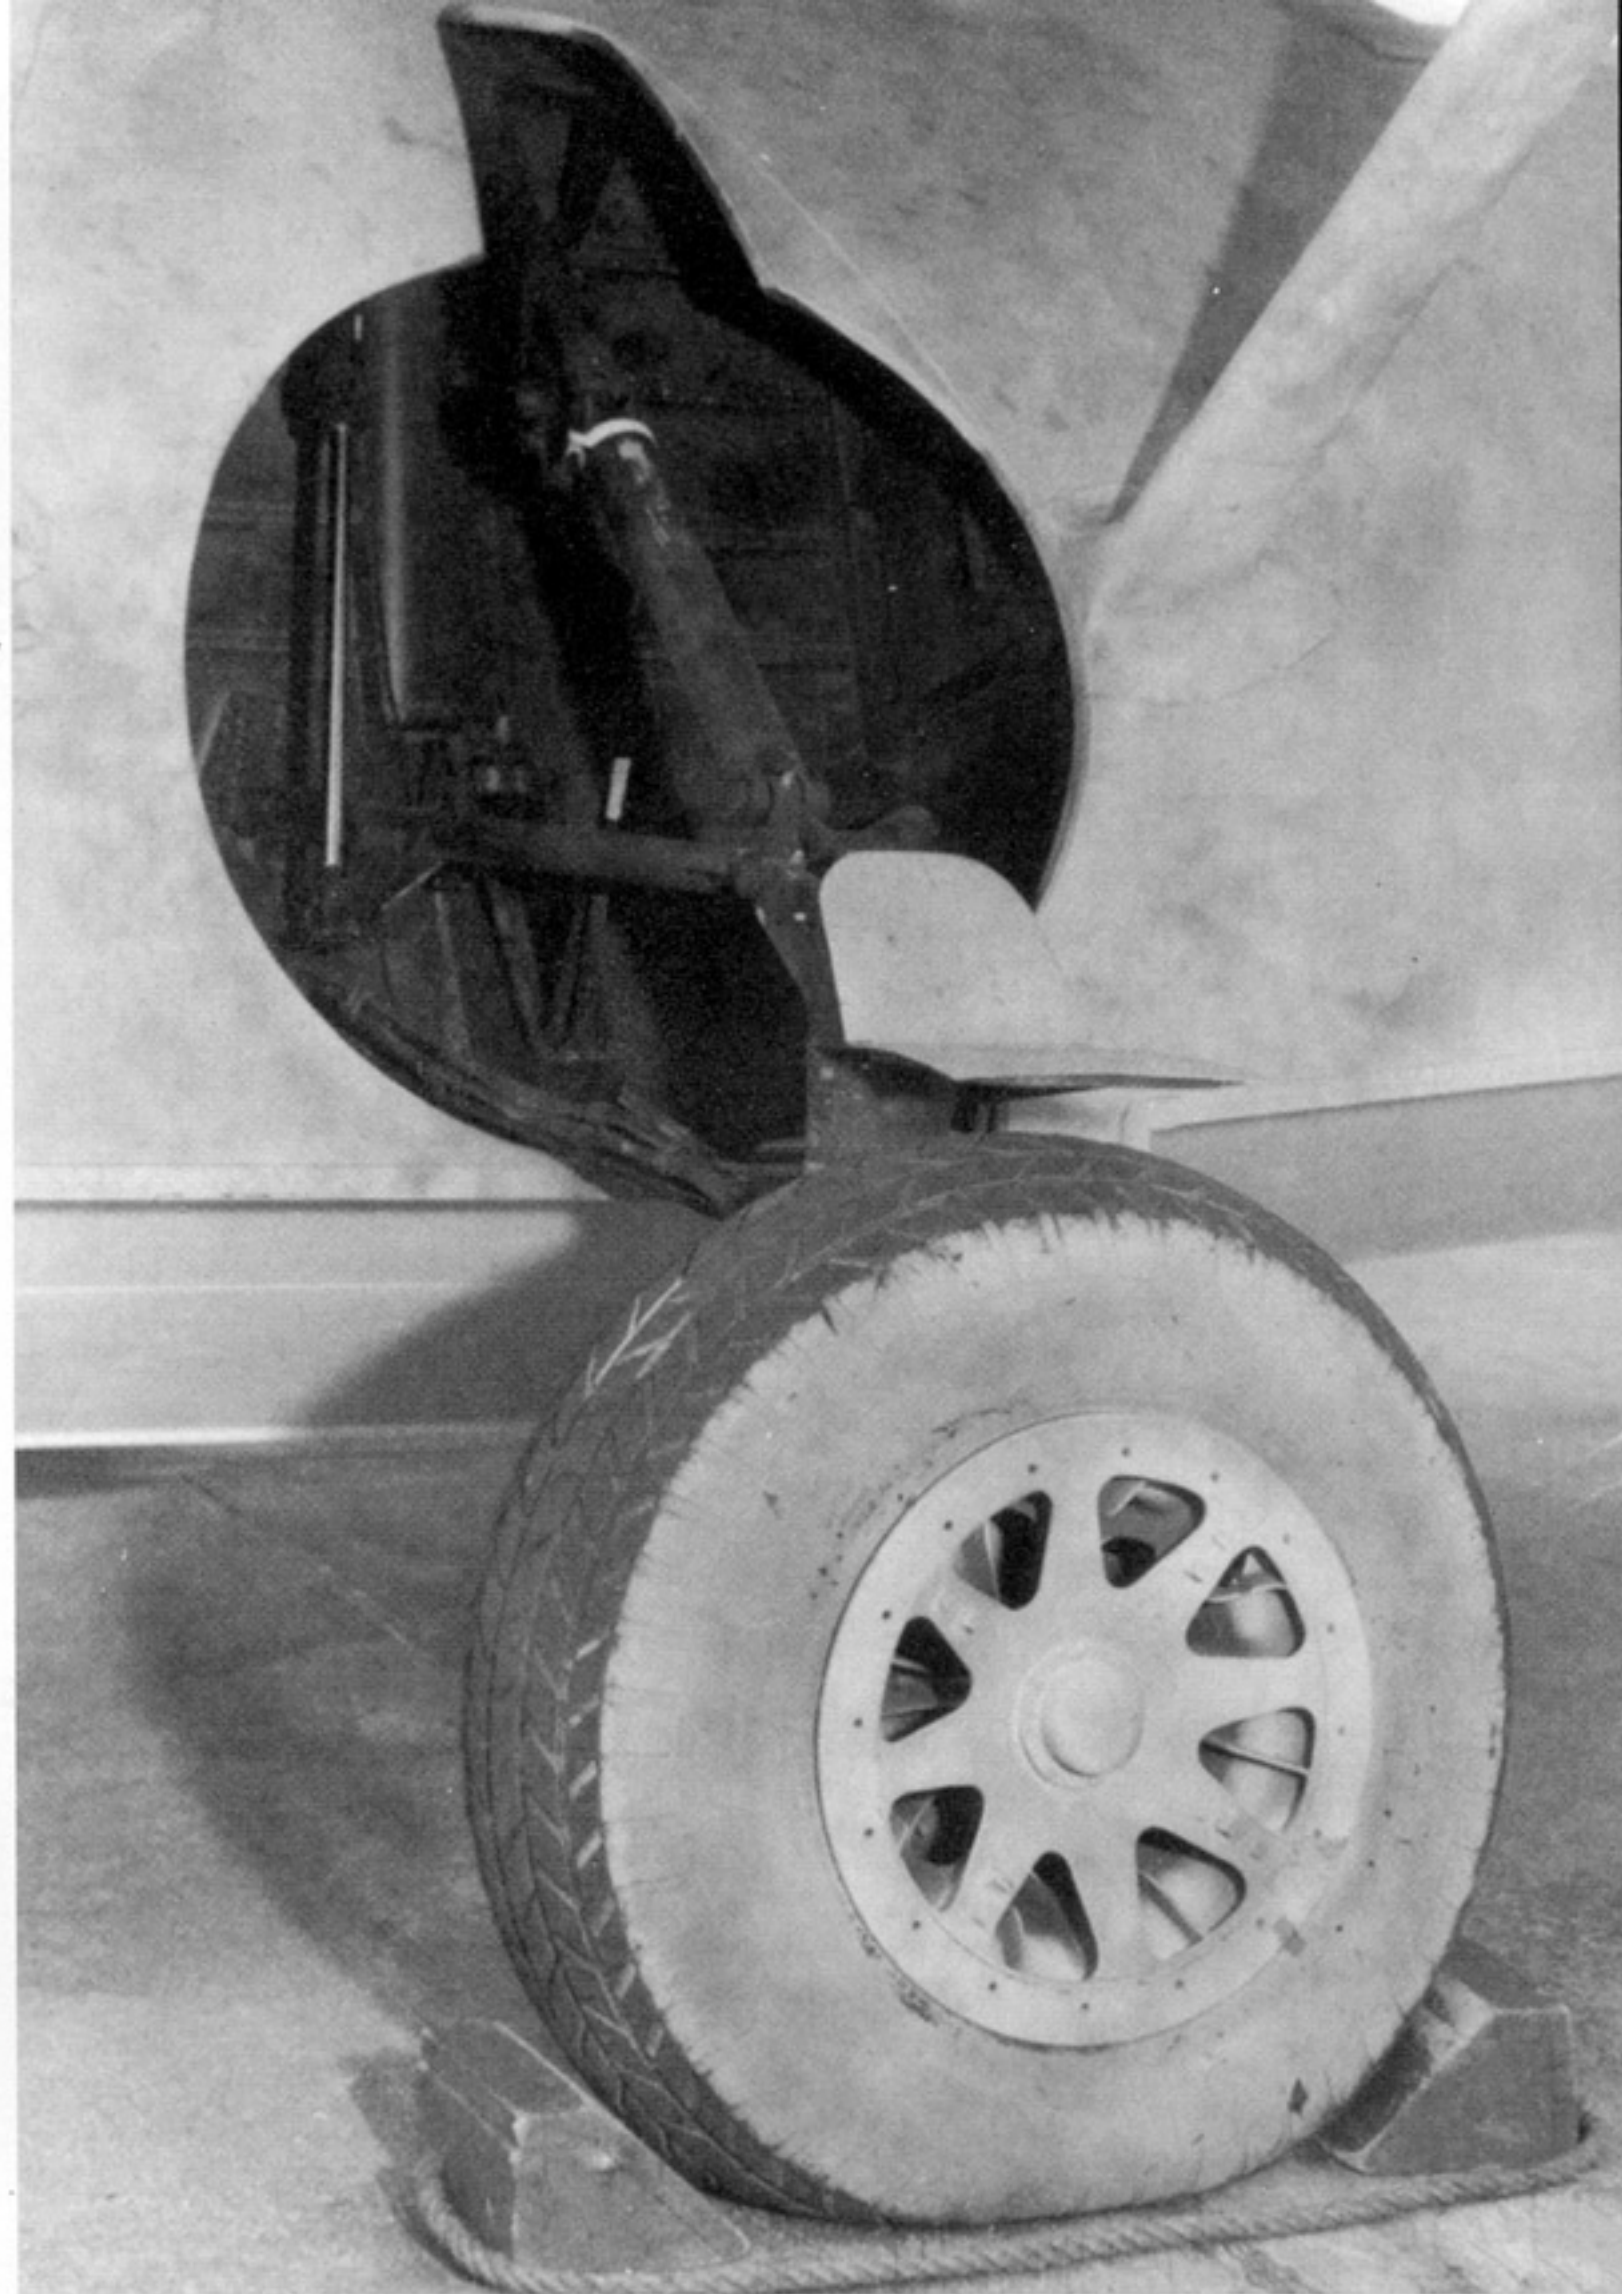
The PBV-5A main landing gear had the telescopic actuator strut (top) and smaller upper and lower vee support struts attached by bolts directly to the oleo strut, along with the small two piece landing gear well doors. (Tom Tullis)

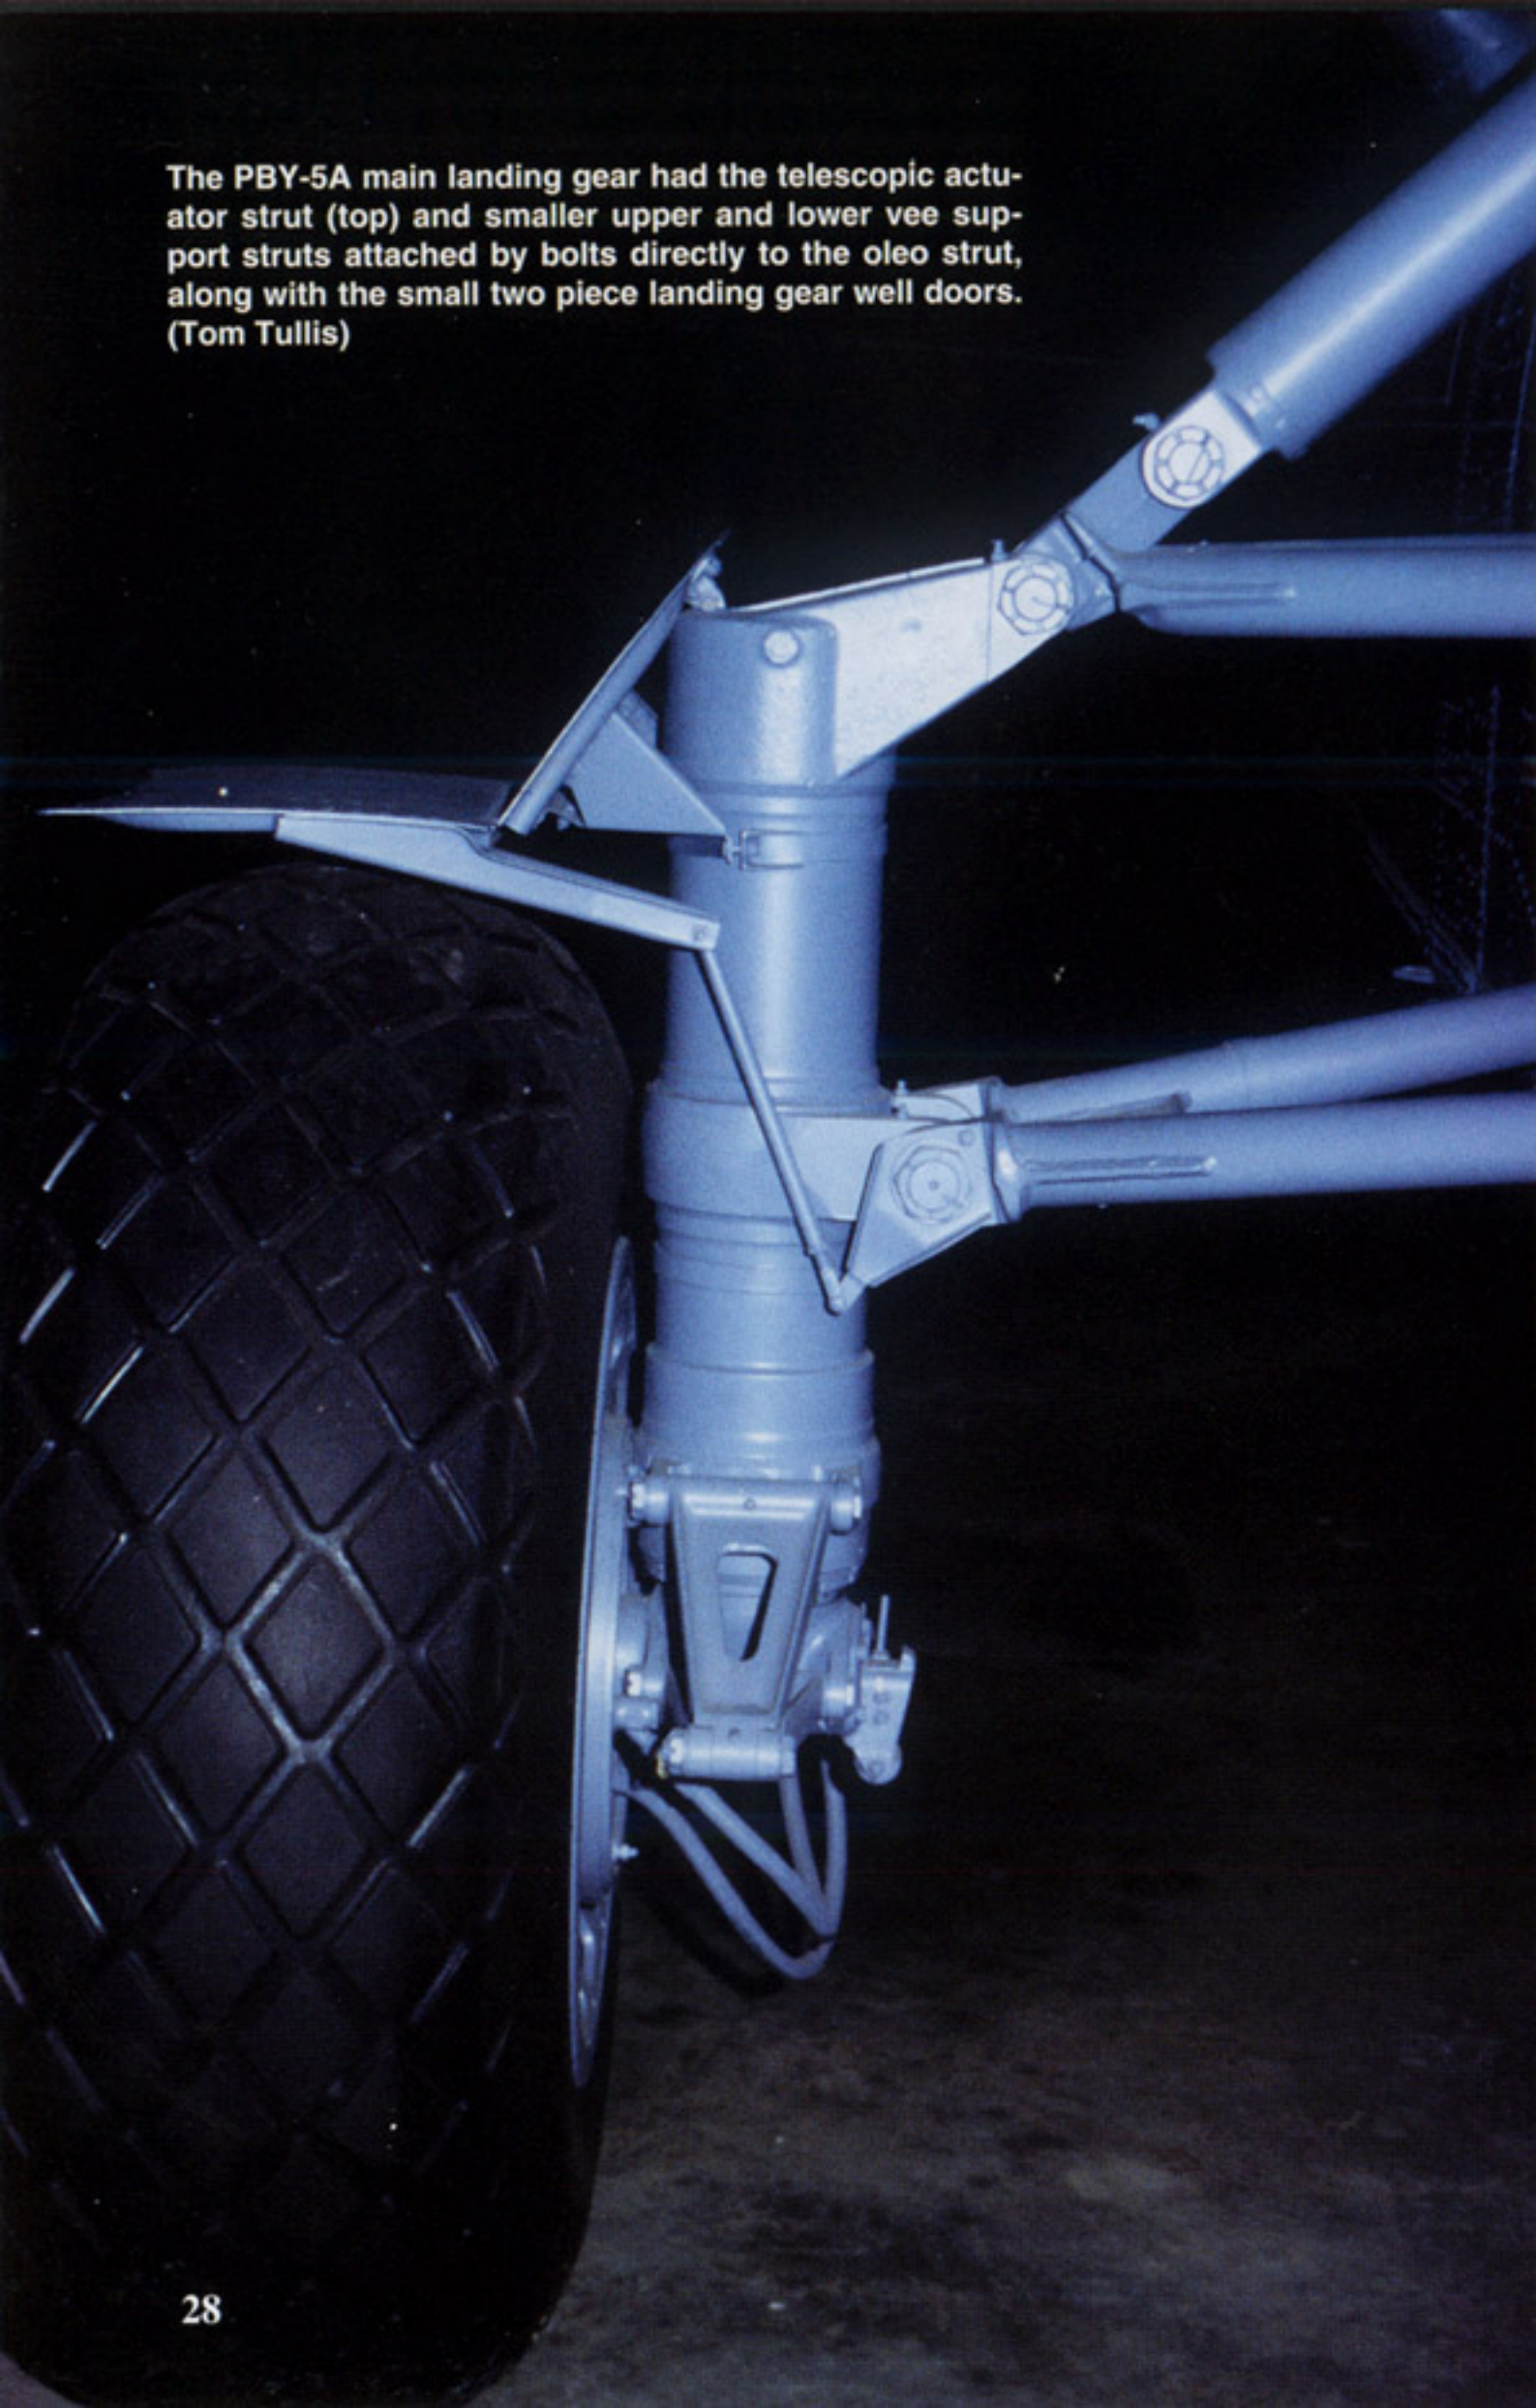
The main landing gear retracted upward and inward to rest in the main wheel well in the side of the fuselage of the PBV-5A/OA-10A. The upper strut was the telescopic actuating strut, while the two lower struts were the upper and lower pivoting vee support struts. Landing gear retraction was hydraulic. (Tom Tullis)

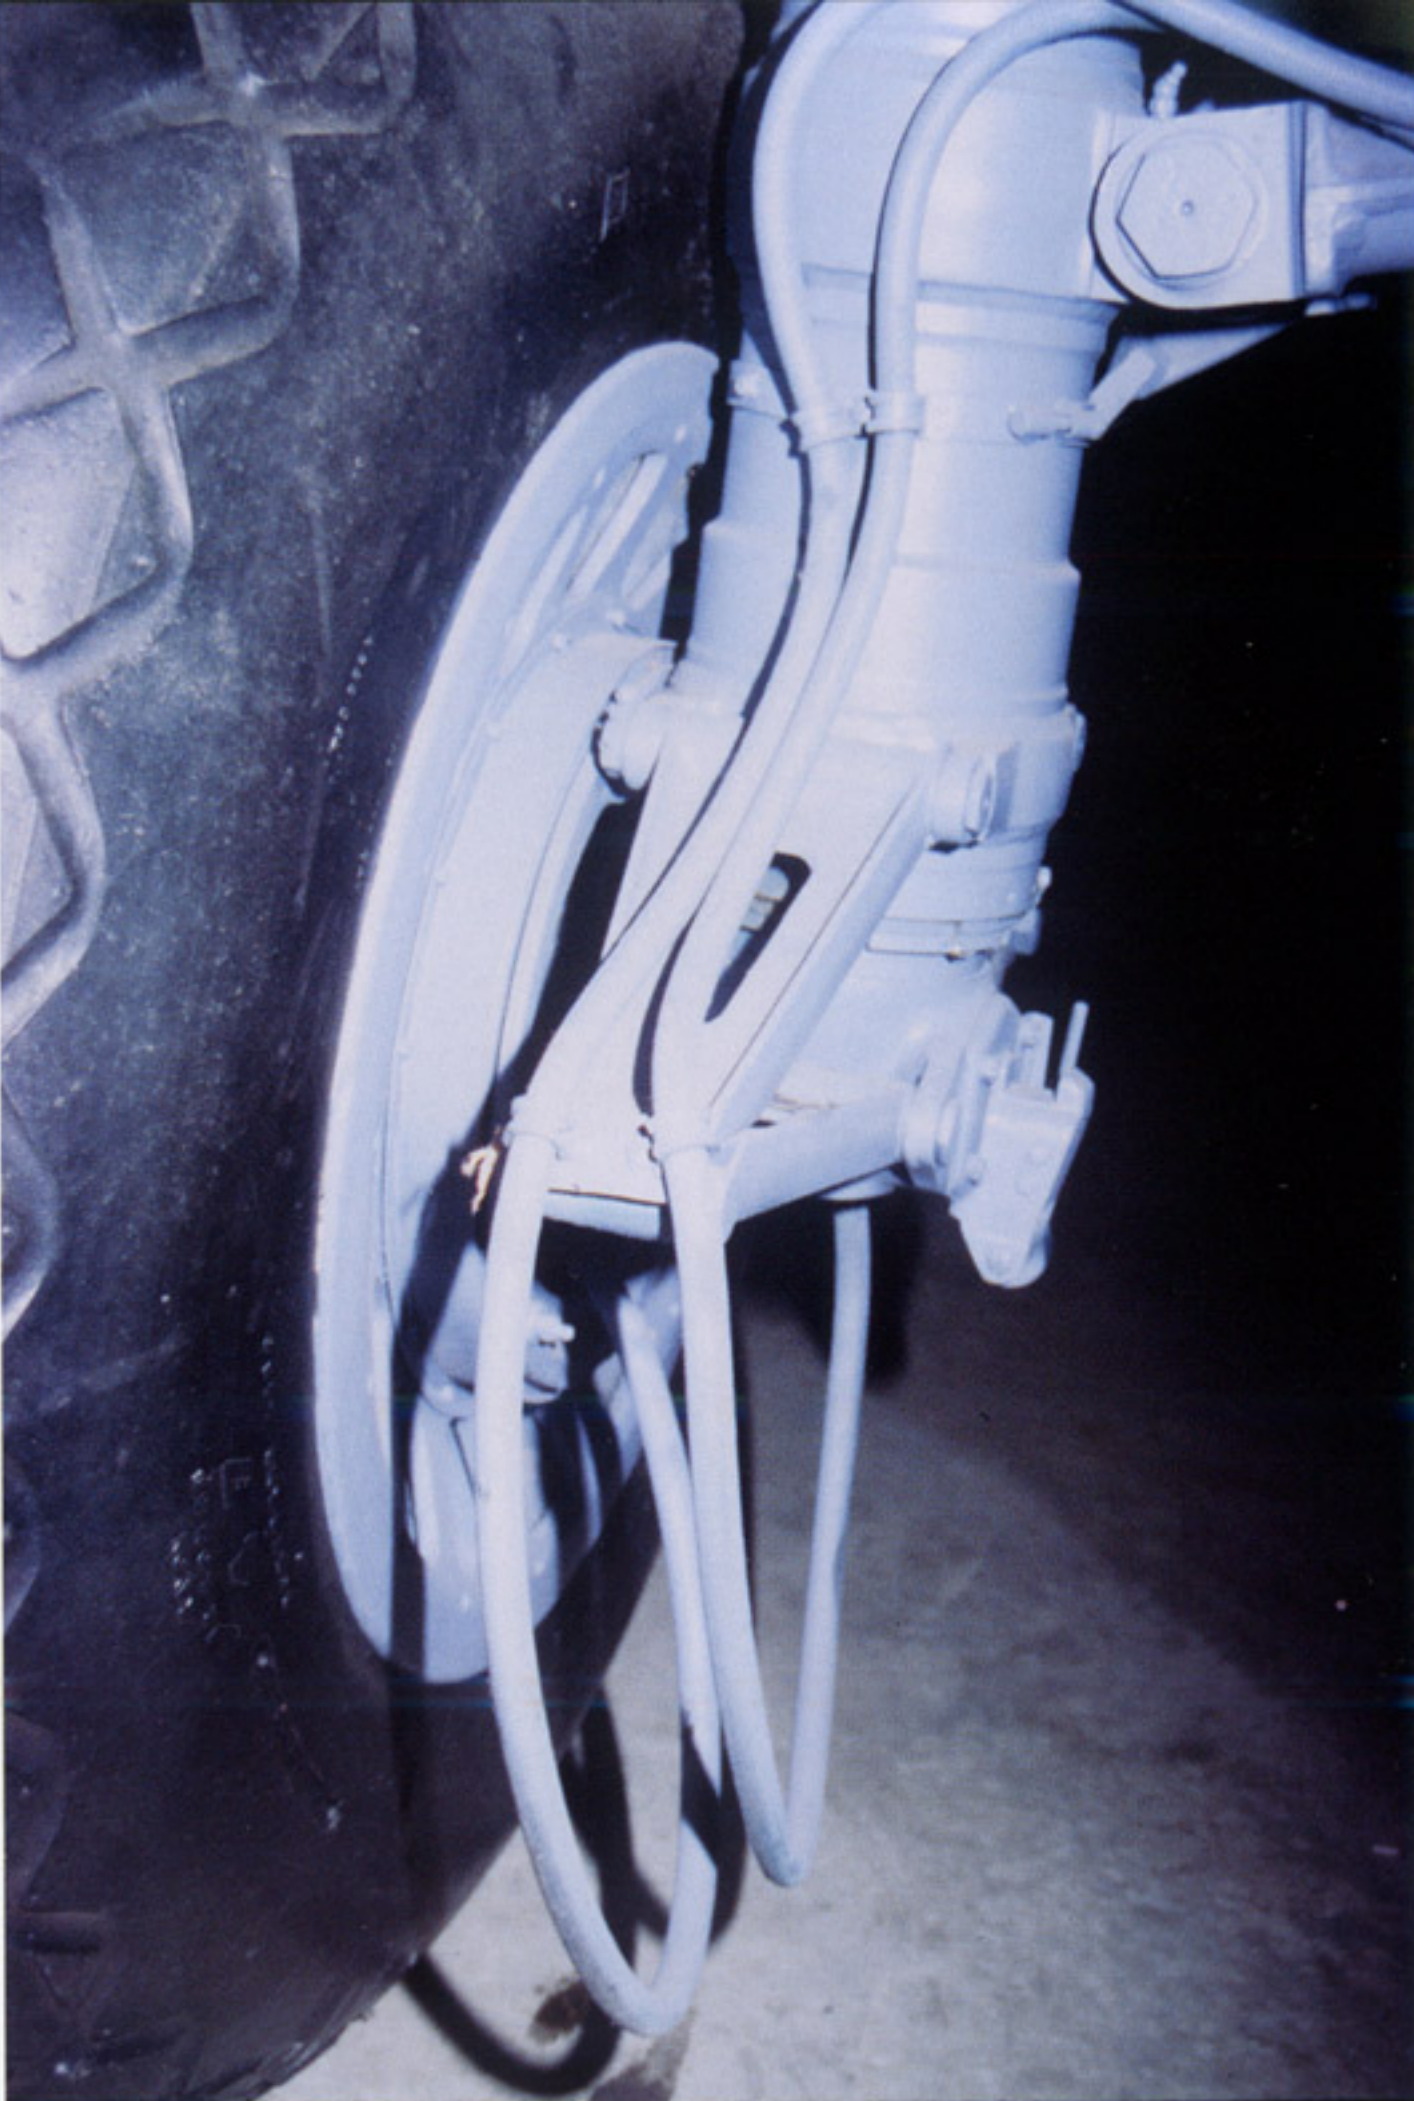
The main landing gear of the Air Force Museum's OA-10A. Normally the hydraulic lines extending down over the oleo strut scissors would be Black and not so slack. The thick plate against the wheel is the brake torque plate. The PBY-5A was equipped with disk type brakes and and either smooth and treaded tires. (Tom Tullis)

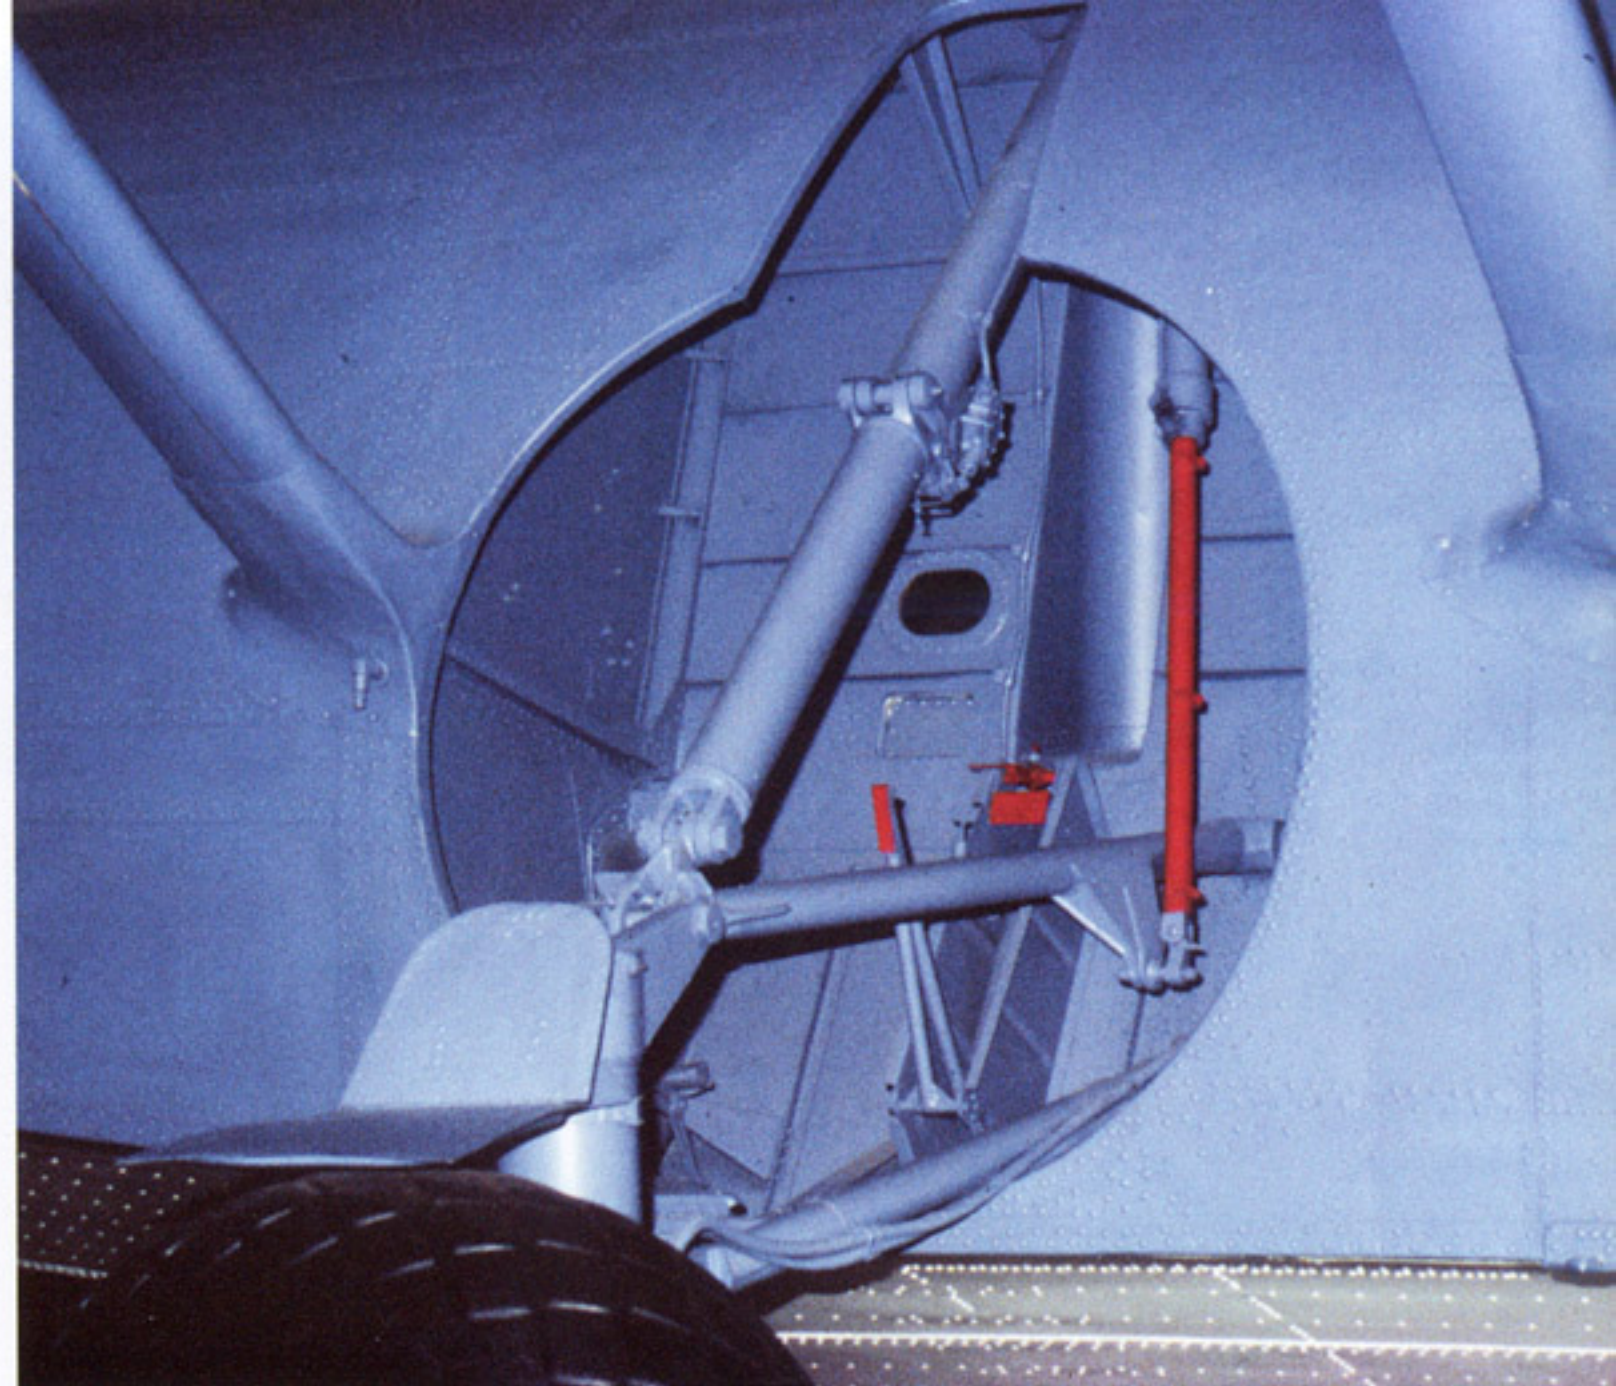
The Red color of this strut on the Air Force Museum's OA-10A identifies the part as being a non-standard locally fabricated part. There are two sets of Vee struts (upper and lower) that support the landing gear. (B. Ryle)
